K-256

Cacaway Farm
Broad Neck
1st Quarter 19th Century

Maryland Historical Trust State Historic Sites Inventory Form

CACCAWAY (K-256)

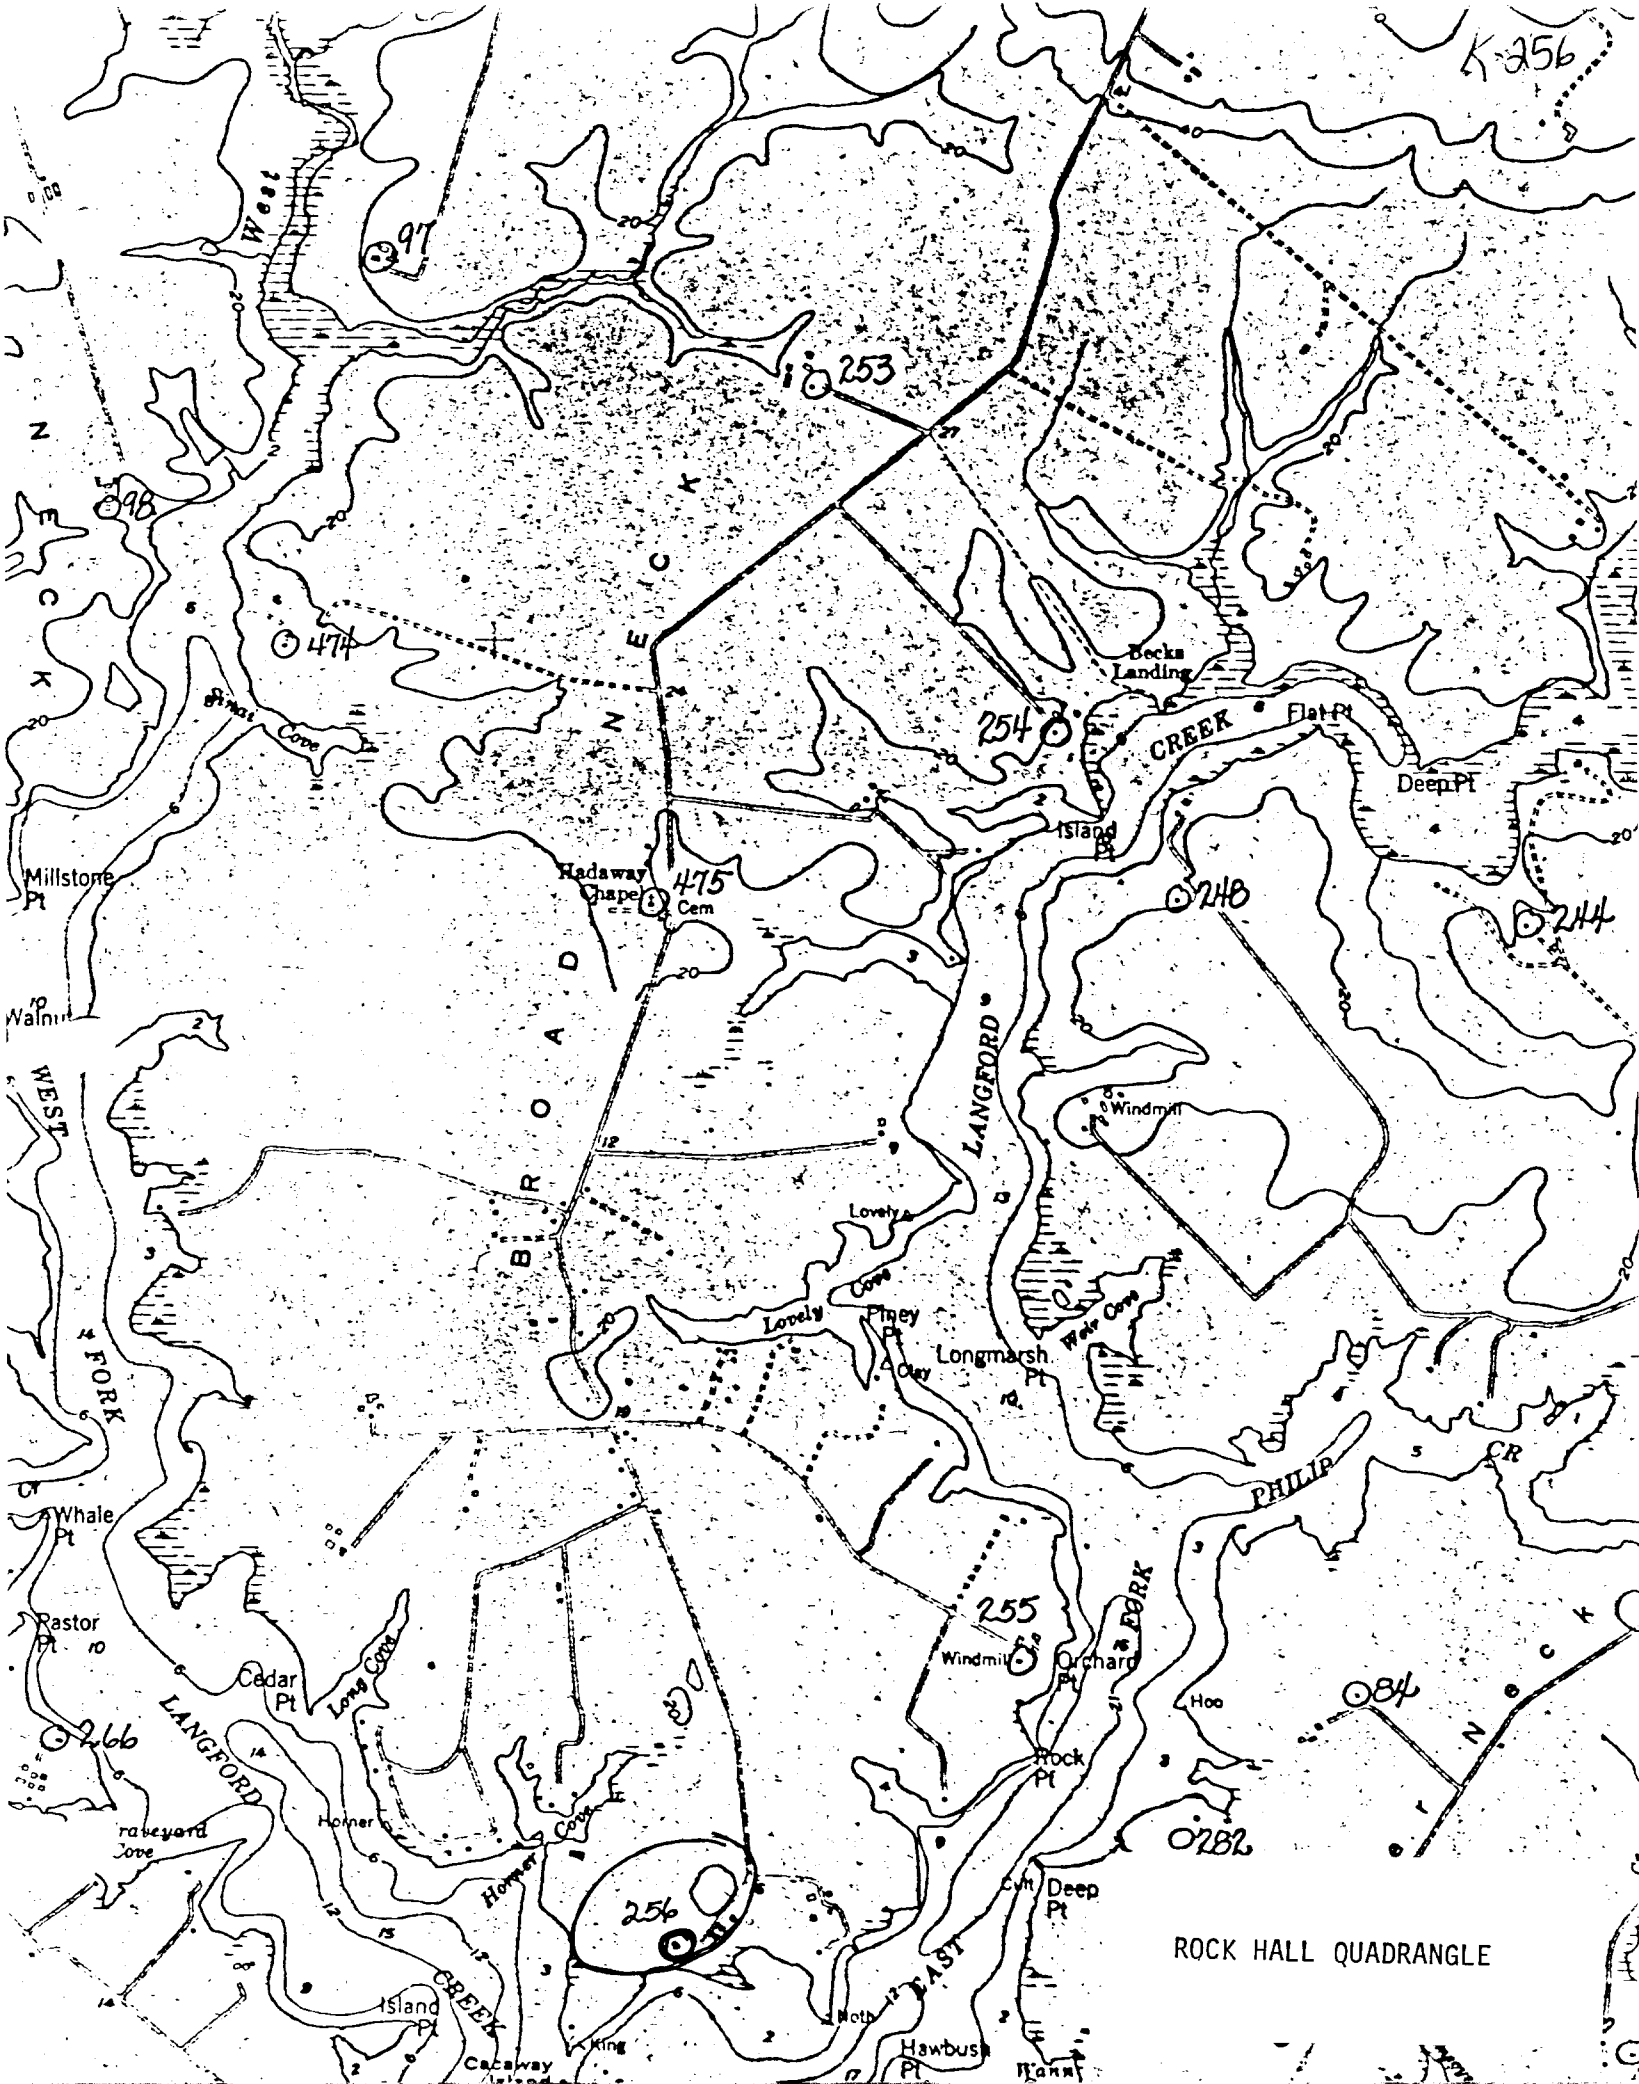
2. NAME <u>Cacaway Farm</u> DATE OR PERIOD <u>18th Century</u> STYLE ARCHITECT BUILDER		3. FOR LIBRARY OF CONGRESS USE	
4. NOTABLE FEATURES, HISTORICAL SIGNIFICANCE AND DESCRIPTION OPEN TO PUBLIC <u>No</u> <p>Only the east wing of the house on Cacaway Farm has any age.</p> <p>It is a two-bay long, one and one-half story brick structure painted white. It sits in a grove of trees and looks over the Langford Bay.</p>

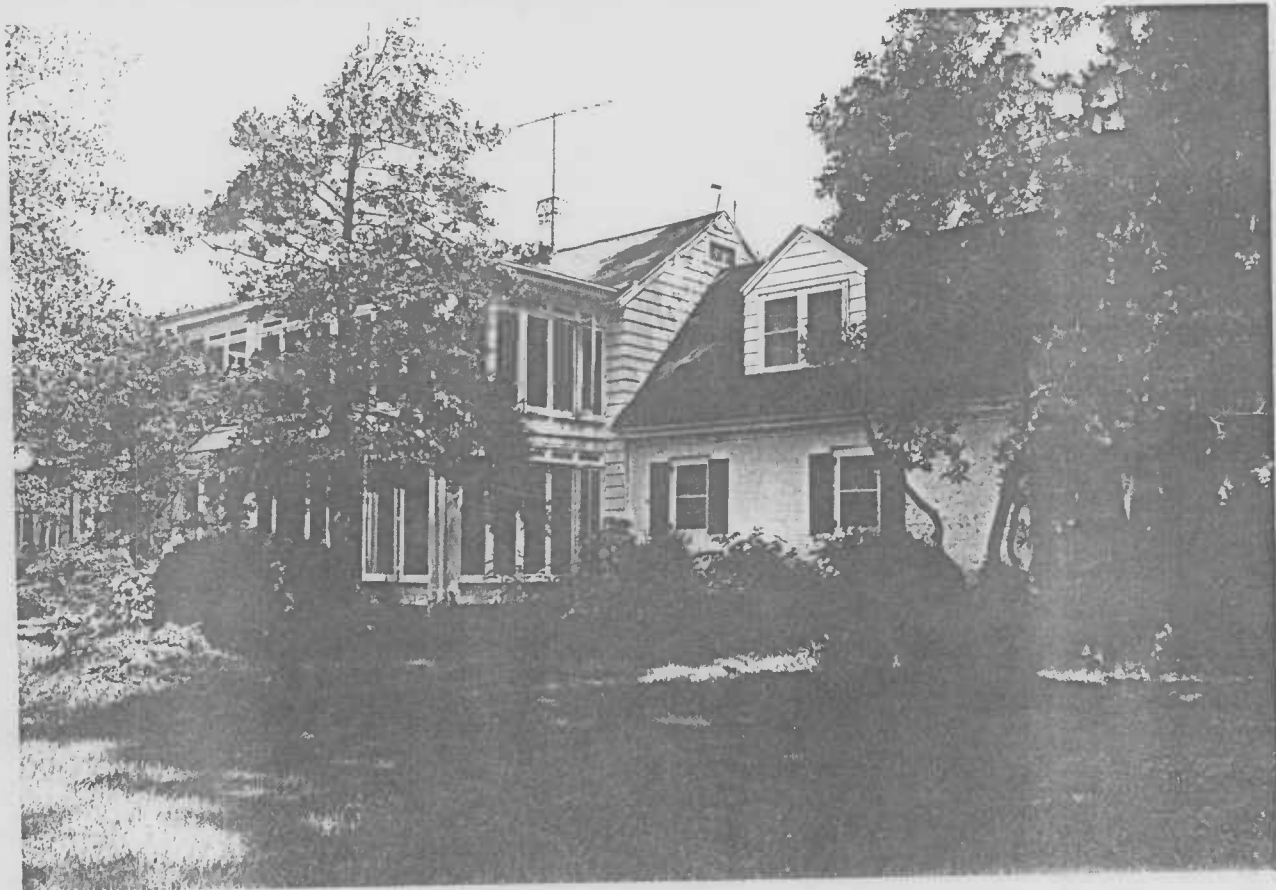
View to North

Broad Neck, Chestertown, Kent County
